# Changing NEEDS

Elegant, exposed steel moment-resisting frames replace a Cambridge, MA warehouse's crumbling CMU walls.

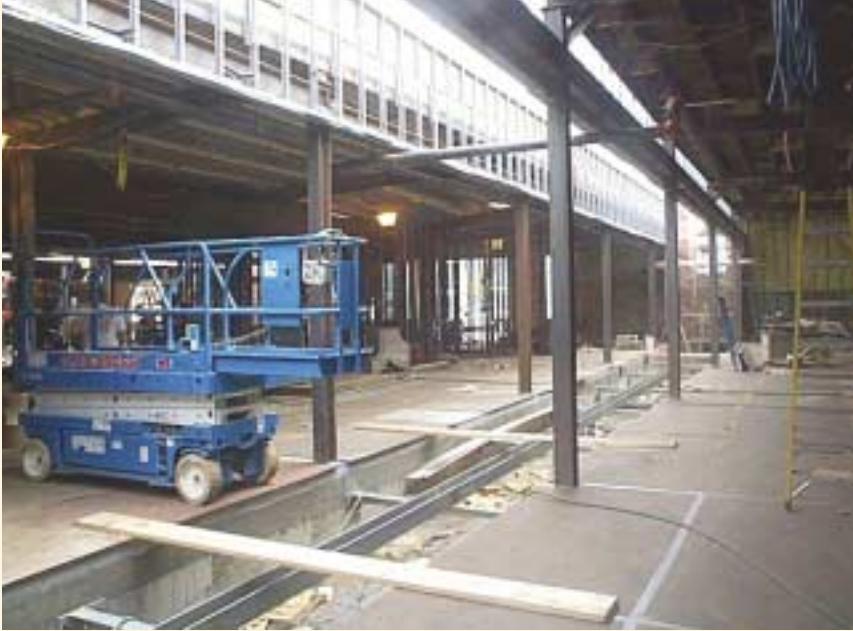
CMU walls dividing each building from an enclosed alley were replaced with new steel framing. The old alleys (the narrow area between the columns in this picture) became atriums.

Since the CMU walls at the interior of the building were to be replaced by glass windows along the adjoining lines of the three buildings to create the

atriums, new moment frames had to be added to replace the lateral load resistance of the CMU walls.

The allowable lateral shear stress and the corresponding lateral load in the existing un-reinforced CMU walls were calculated and used in the design of the moment frames. The final moment-frame member sizes of 6" wide-flange columns and 10" wide-flange steel girders helped to achieve the elegant look of the atrium. Use of bracing was not an option as it would have obstructed the views through the atriums.

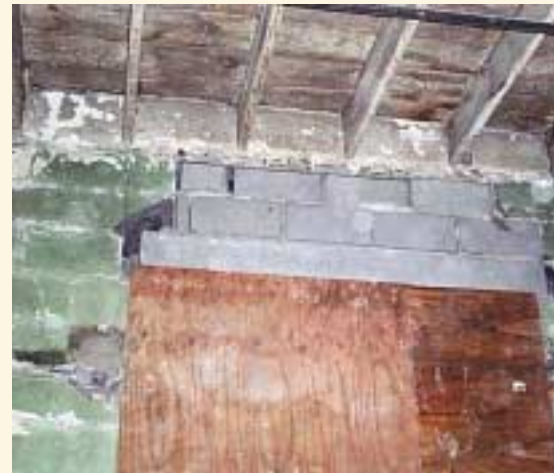
The existing masonry dividing walls were in very poor condition.

The original structure consisted of five, single-story buildings arranged side by side and separated by alleyways which had been enclosed and abandoned. The alleyway walls were cracked and severely deteriorated. The roof structure was under-designed and

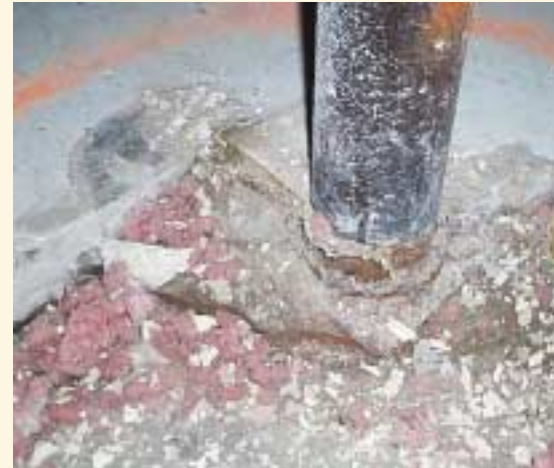
Many existing column bases were deteriorated.

During the progress of the project it became apparent that interior deteriorated columns and footings of the project would have to be replaced. There was no solid concrete foundation under the columns. The columns rested on two or three courses of brick with a 16" x 16" dimension, supported in part by a 16" x 16" concrete base that was 16" deep.

Some of the existing columns were observed to have rusted and deteriorated at the base. There were no anchor bolts attaching the column bases to the brick piers.

In the initial design, the structural drawings contained remedial details for reinforcing the column bases by placing concrete around the existing

16"x16" footing, and tying the existing base plate to the new concrete by welding bent bars (to be embedded in new concrete) to the base plate. As the excavation continued and the existing slab was removed, it became apparent that the material under the slab had to be compacted for placement of the new slab. The contractor and the geotechnical engineer were concerned about the danger of separation and slippage of the columns from their existing foundations during vibration of the soil, and the possibility that the roof structure could collapse during compaction of the base material of the new slab. New 5"-diameter steel pipe columns were added throughout the building to replace existing deteriorated columns. New footings were designed for the new columns.

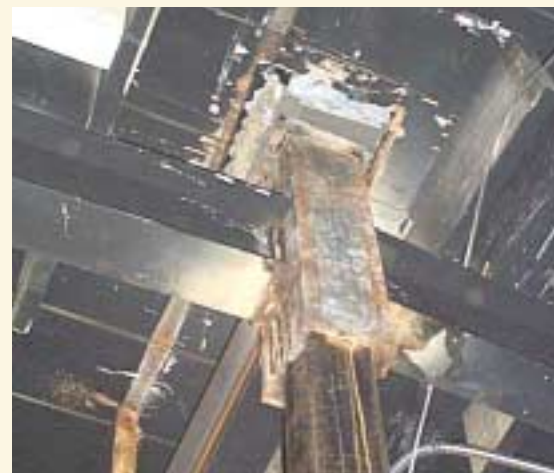
Channels attached to each side of the existing columns extend through the roof to support additional loads.

New steel roof members were added to support the new atrium structure, the skylights, and the new conference area. New steel dunnage structures were added to support the new mechanical roof top units. Two channels attached to either side of the new columns extended through the roof framing to support the base plates of the new dunnage columns. Finally, the existing roof deck was tied to the peripheral supporting members to transfer the lateral loads to the lateral-load carrying elements.
